This Old Courthouse

The Official Newsletter of the Comal County Courthouse Restoration

October 2011

The Courthouse is getting a new basement

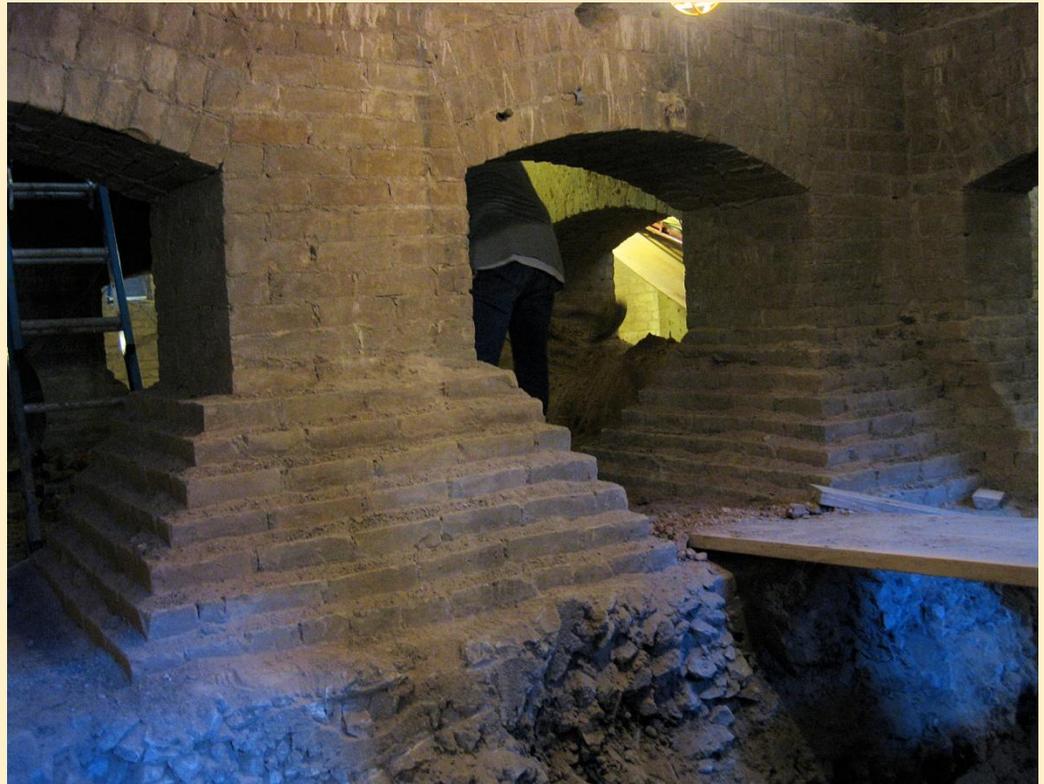
As part of the restoration process, the Courthouse will get much more space in the basement. The Courthouse originally featured a very small basement area, with the majority of the space under the first floor being a 2-foot high dirt floor crawlspace. The image above shows how the original foundation was constructed. In 1898, the workers excavated the area for the foundation. Next, they poured unreinforced footings made of cement and large aggregate. On top of that, they built pyramid-shaped masonry footings. Finally, they built the masonry columns that provide the primary structural support for the entire building. The area was then backfilled with dirt to a point where the pyramid-shaped footings were buried, leaving only a small crawlspace. A few areas had been excavated over the years to make space for storage. Objects had been tossed into the crawlspace over the years, such as bottles, Ford Model-T tires, and floor tiles.

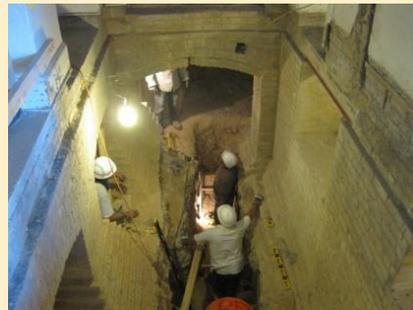
Workers excavating in a corridor

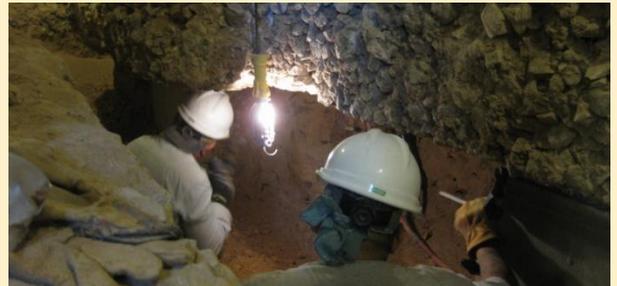
Here they dig underneath the 1898 foundation for the new underpinning.

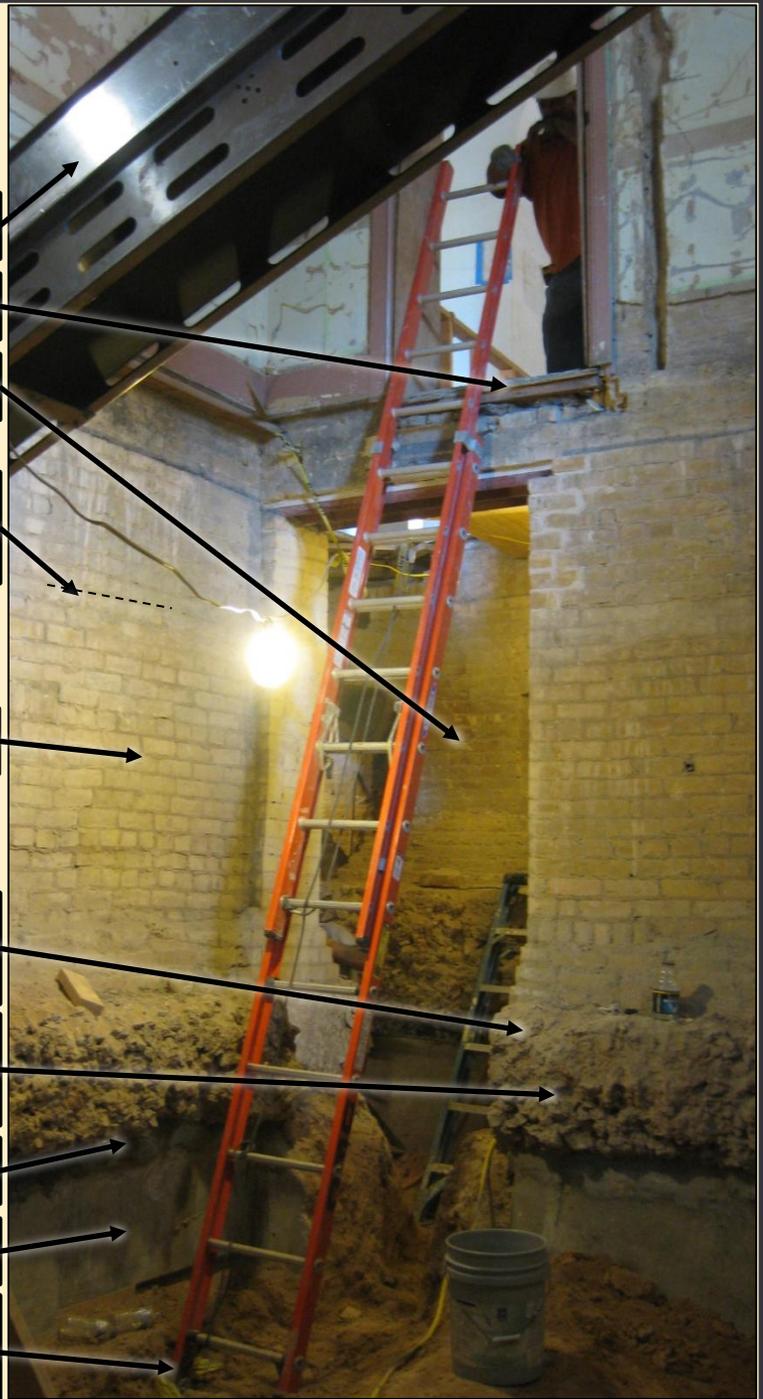
Extending the foundation underneath the original 1898 Courthouse

Conveyor for Dirt Removal

Threshold for a 1st Floor Doorway

New Basement Doorway Cutout

Top of Original Dirt Floor Crawlspace

1898 Masonry Foundation Beam

1898 Pyramidal Foundation Footing

1898 Unreinforced Concrete Footing

Bottom of 1898 Foundation

New Concrete Underpinning

Proposed Finished Basement Floor Elevation

This exhibit shows the effort that goes into creating a new basement underneath the Courthouse. The contractor first has to remove an enormous amount of dirt to expose the existing foundation. Next, they excavate under the 1898 foundation and pour concrete to extend the foundation, approximately 3 feet deeper. Finally, a concrete basement floor will be poured.

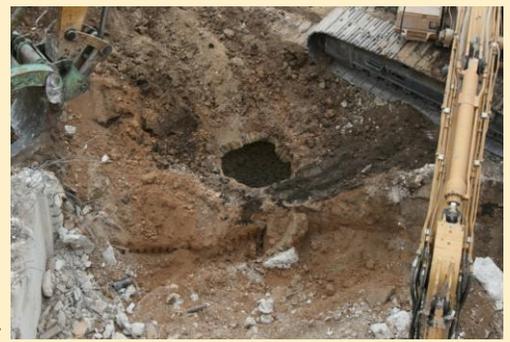
During the excavation for the removal of the Jail foundation, the contractor exposed the existence of a previously unknown water well. The worker immediately stopped work so that the project architect and representatives from the Texas Historic Commission could evaluate the significance of the feature. The THC sent an expert, Mark H. Denton of the Archeology Division, to evaluate the situation and give direction. Mark said, "The well appears to be primarily constructed of small, rough-cut limestone, and the upper structure of the well appears to be mortared. Lower components of most wells are, however, often not mortared so that the water from below-surface aquifers can seep into the structure." He said the well, which pre-dates the courthouse, had been dry for a long time, and needed to be filled in to prevent a cave-in and to preserve its structural integrity.

Well as originally discovered by the excavator

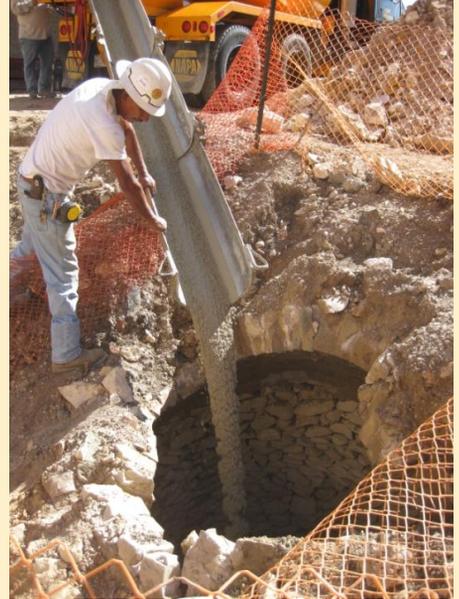
Well being backfilled with flowable fill
